# Digital Workflow for Posterior Maxillary Rehabilitation with Monoblock Zirconia Implant

Saurabh Gupta, BDS MDS

This case study records the single-piece zirconia implant as a replacement for failed endodontic treatment of first maxillary molar tooth. The procedure started with atraumatic extraction of molar tooth and followed by immediate placement of monoblock zirconia implant. Good primary stability was achieved and the zirconia implant was restored with zirconia crown after 6 months. Follow up after a year disclosed success in osseointegration with optimum form and function.

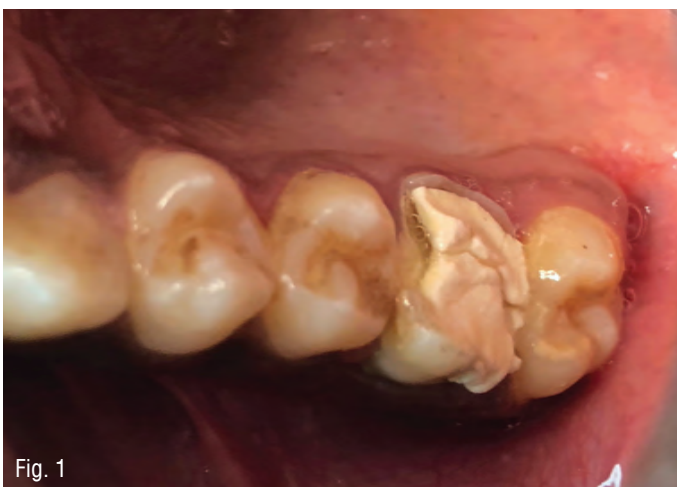
Fig. 1

A female patient (21 years old) came complaining about her molar tooth in the upper right jaw being fractured [Fig. 1].

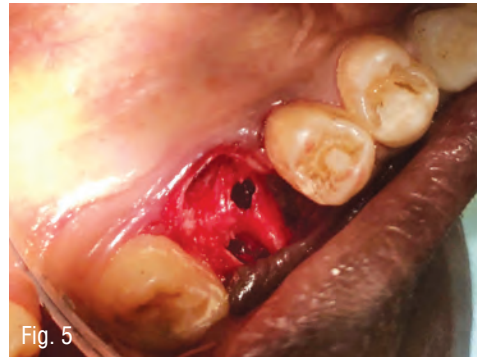
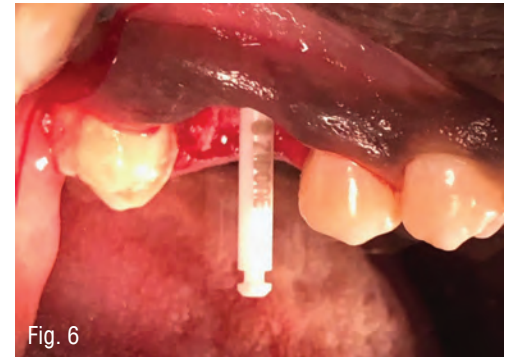
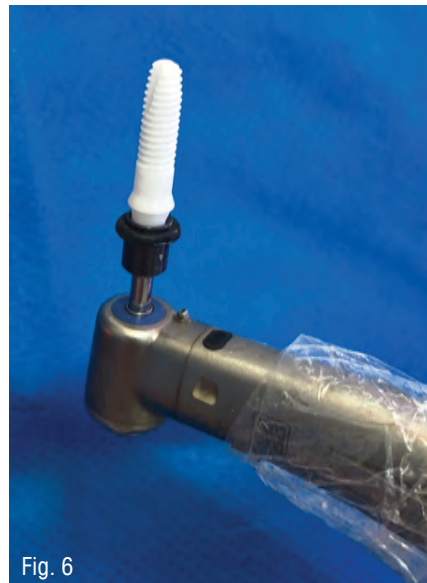
Fig. 5

Extensive maintenance and ultrasonic scaling was performed before the tooth extraction and the placement of zirconia dental implant. Under 1:200000 adrenaline in local anesthetic, atraumatic extraction surgery was performed with the use of a periosteal elevator for the removal of the failed root canal-treated tooth [Fig. 3]. Extraction space was exhaustively debrided with the use of bone curettes. Manufacturer's instructions have been followed in the preparation of implant bed [Fig. 4]. For the preparation and maintenance of straight vertical position for zirconia implant, implant indicators

have been used [Fig. 5,6]. Zibone zirconia implant (COHO Biotechnology) with 4mm diameter and 11.5mm length and about 4mm abutment height was placed immediately with optimal stability (35N) after the atraumatic extraction [Fig. 7]. Bone cement (Augma Biomaterials) was used for filling the extraction void between bone and implant and covered further with collagen membrane to enhance vestibular contour ridge for a more natural looking crown [Fig. 8,9].

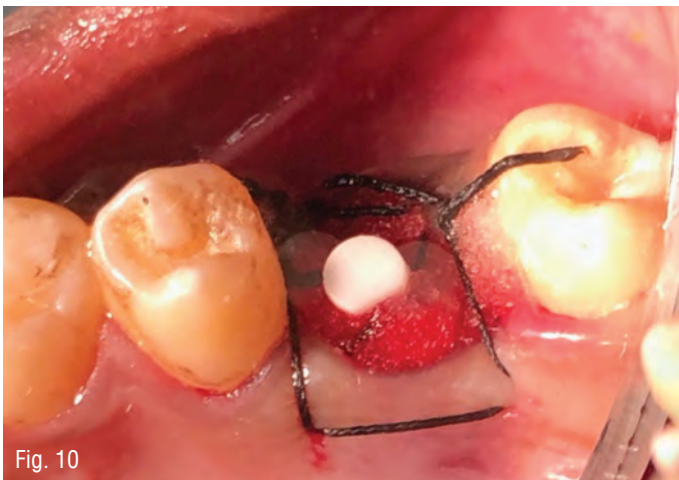
Fig. 10

The site was approximated with suture 3-0 black silk material [Fig. 10] and radiograph was taken [Fig. 11]. Prescriptions included pain killers, antibiotics and betadine mouthwash, and homecare postoperative instructions were also given. After seven days, the sutures were then removed, at that time there was sufficient visible wound healing. Additionally, a PMMA tentative restoration was fabricated and given straightaway after the removal of suture [Fig. 12].

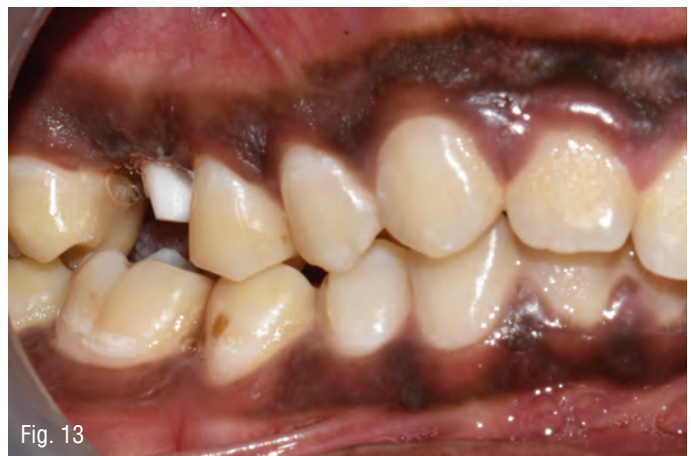
Fig. 13

crown after six months [Fig. 13,14]. The abutment part was prepared with the use of Magic-Touch burs (Strauss & Co.) and a 3shape trios intra-oral optical scan was directly taken on the mono-bloc zirconia's abutment portion [Fig. 15,16]. Zirconia implant restoration intaglio surface was cleaned and primed with double coating of Z-Prime plus (Bisco) and cementation was done with 3M ESPE resin self-adhesive cement [Fig.

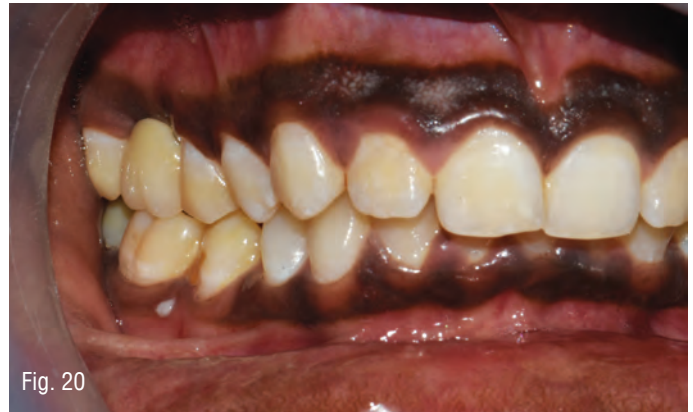
Fig. 20

no technical complications were seen during the said time frames. The soft tissue that surrounds the implant was seen to be quite healthy. One year after the placement of the zirconia implant the surrounding bone remodelling was normal with a stabilized bone boundaries [Fig. 20]. The patient was satisfied with the treatment procedure with respect to function and aesthetics.
