Management of Locked Non-Retrievable Implant-Retained Overdentures - Case Reports

This paper will describe two related case reports. The first is on a 75-year-old female and describes the management of a locked-in mandibular implant-retained overdenture with individual attachments. In this case, attempts to pick-up the attachment matrix intraorally led to locking-in of the prosthesis due to inadequate and inappropriate block-out of the abutment. The second case describes the process of intra-oral pick-up of prosthesis matrices on a milled bar retaining a maxillary overdenture, in a 60-year-old male. This procedure resulted in locking of the prosthesis and the management of the situation is described.

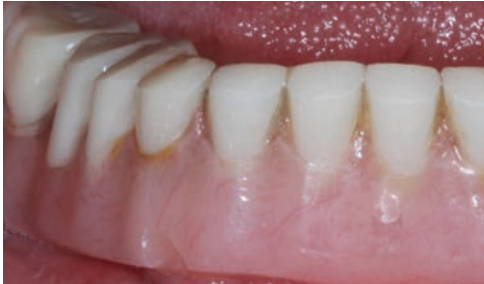
Fig 1: Initial clinical presentation displaying damage to the prosthesis acrylic base on the buccal flange border, mesial of the 43 prosthetic tooth site as a result of patient's efforts to remove the prosthesis with a metallic fork. Soft tissue swelling can be observed at the edge of the flange.

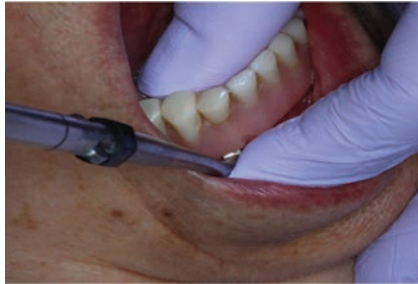
Fig 2: Initial attempts to remove the prosthesis by a crown removing back-action hammer were not successful in retrieving the locked-in prosthesis.

Management: Initially the “back-action hammer” was used to attempt dislodgment the prosthesis from the underlying abutments (Figure 2). It was evident that the prosthesis was loose on the left side and completely non-retrievable on the right side. In an attempt to isolate the force to the 43 region, the 33 site was held down while the removal force was applied. This procedure was not successful and therefore the decision was made to cut through the prosthesis to separate the matrix. Choosing this method could cause significant damage to the prosthesis.

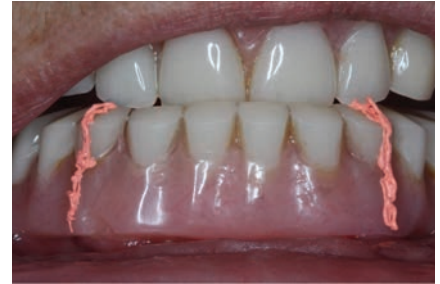
Fig 3: Gutta-percha radiographic markers were placed on the prosthesis in the 33 and 34 sites to aid in localizing the implants, attachment and matrix components.

markers were placed on the buccal surfaces of the 33 and 43 prosthetic teeth extending onto the buccal polished surface (Figure 3) and periapical radiographs were obtained. It was confirmed that the locations of the implants were associated with 33 and 43 prosthetic teeth (Figure 4). A round acrylic bur was used to cut a conservative trough around the estimated location of the 43 implant and abutment lingual to the 43 prosthetic tooth. This was undertaken with no damage to the prosthetic teeth (Figure 5). After visualizing the matrix metal and confirming accurate location of the trough, a diamond bur in a high-speed hand-piece was utilized to complete the trough around the attachment components.

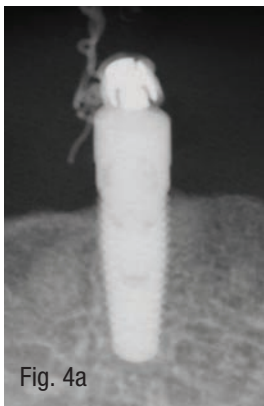
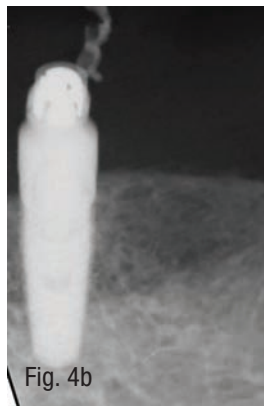
Figs 4a-b: Periapical images showing the gutta-percha markers, which were placed on the buccal surface of the prosthesis to localize the underlying implants and associated components. Markers confirmed that the implant locations were associated with 33 and 43 prosthetic teeth on the overdenture.

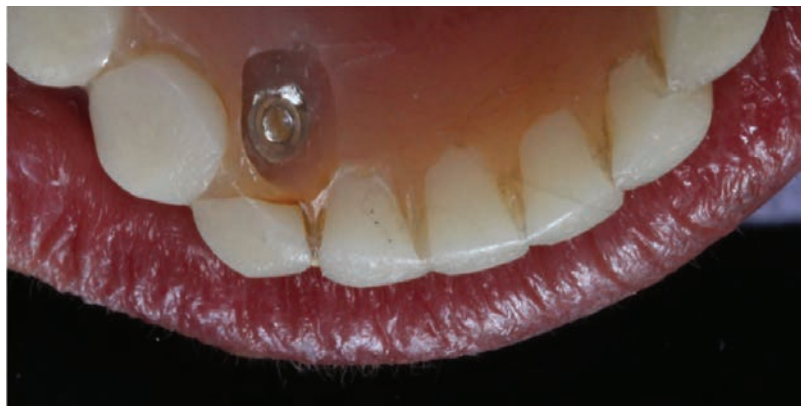
Fig 5: A conservative trough was cut around the 43 matrix component without damaging the prosthetic teeth.

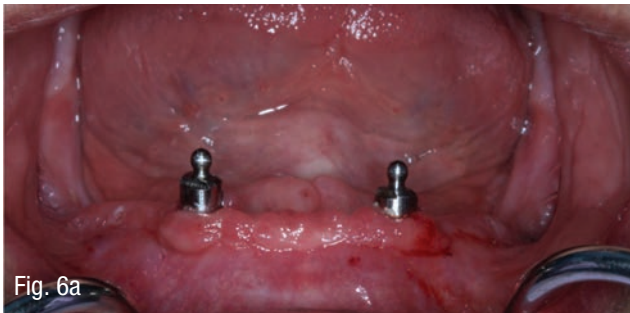
Figs 6a-b: Clinical presentation of the underlying soft tissues after removal of the locked-in prosthesis (4 weeks) exhibits tissue inflammation.

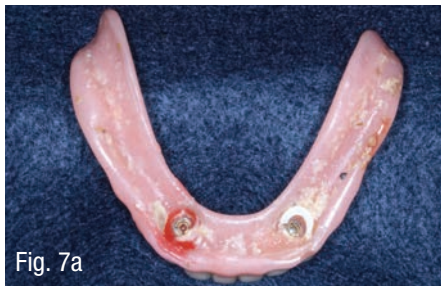
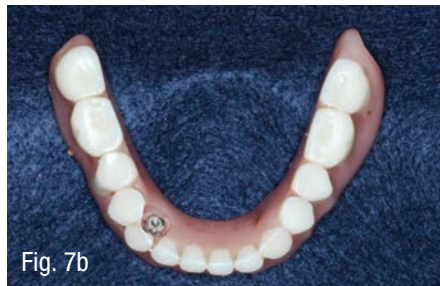
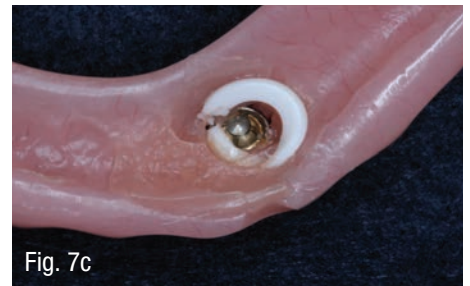
Figs 7a-c: Appearance of the prosthesis after removal, note the food debris, damaged attachment matrix, O-ring and excess acrylic leading to locking-in of the prosthesis.

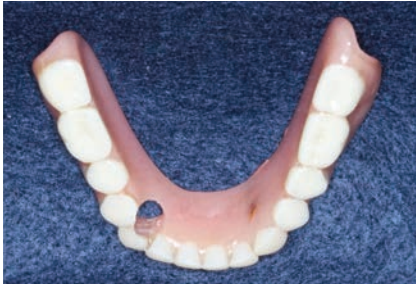
Fig. 8: Enlarged vent hole without damage to the buccal surface of the prosthesis is evident.

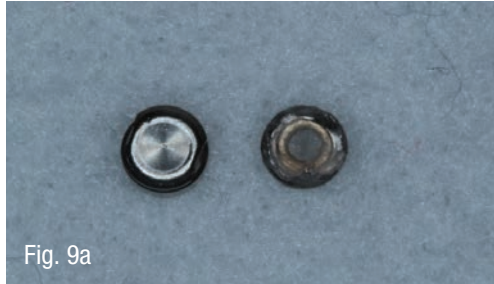
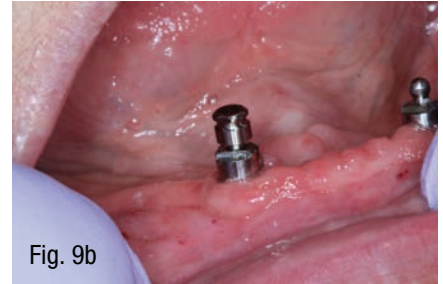
Figs 9a-b: The damaged retrieved attachment matrix (right) and a new attachment matrix (left) for comparison (a). The fresh attachment matrix inserted on the 43 implant ball abutment to be picked up intraorally (b).

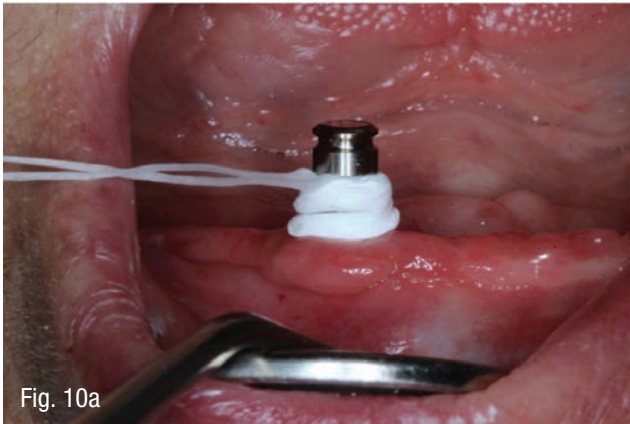
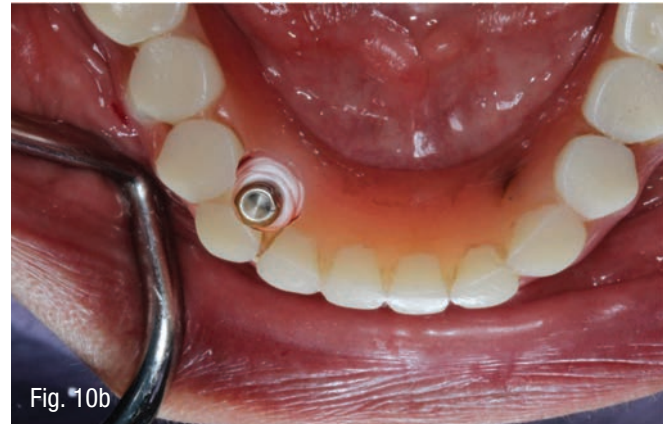
Figs 10a-b: Undercuts inferior to the attachment matrix blocked out with Teflon tape and secured with floss (a). Prosthesis inserted, presence of sufficient space between the intaglio surface of the prosthesis and the metal matrix was confirmed (b).

Upon completion of this step, the prosthesis and attachment matrix were detached from the ball abutment and the prosthesis was removed without difficulty. Subsequently, general erythema of the underlying soft tissues and food debris on the intaglio surface of the prosthesis were visible. It was also observed that the receptacle area associated with the attachment matrix was filled with hard acrylic suggestive of lack of sufficient block-out during previous attempts in picking up the matrix. The matrix component was damaged and not usable (Figures 6, 7). The overdenture and soft tissues were thoroughly irrigated with Chlorhexidine Gluconate 0.12%, the matrix and O-ring were removed and the vent hole in the prosthesis was enlarged and cleaned of remnant acrylic resin (Figure 8). A fresh attachment matrix component (Gold Cap Ball abutment insert, NobleReplace, Nobel Biocare, Canada Inc.) was connected to the 43 implant ball abutment and parallelism with the 33 matrix was confirmed (Figure 9). Undercuts inferior to the matrix were blocked out with Teflon tape, secured with floss and presence of sufficient space between the intaglio surface of the overdenture and the matrix was confirmed visually (Figure 10).

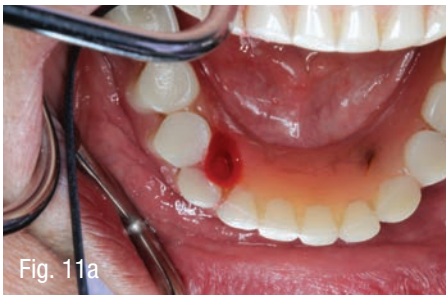
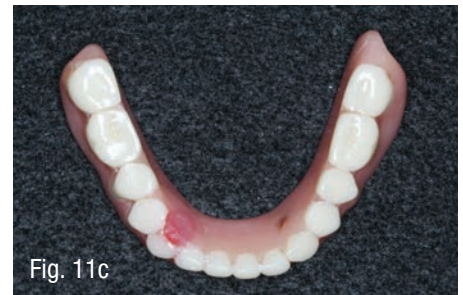
Figs 11a-c: The same prosthetic treatment in the provisional stage. In this second sequence of images, the preparation follows the BOPT technique ^[9]

The new matrix component was picked up with auto-polymerizing inlay pattern resin (Duralay, Reliance, Dental Mfg, Worth, Illinois 60482). Resin was placed on the top and retentive grooves of the matrix and the intaglio surface of the prosthesis. The prosthesis was seated, and after ensuring accurate position using occlusion as a guide, it was held in place with finger pressure. Excess resin was observed to escape through the lingual perforation and the patient was subsequently asked to close in maximum intercuspation position. After completion of polymerization, the prosthesis was removed and acrylic around the matrix was checked to ensure that the component was securely positioned (Figure 11). The result was an optimally retained and retrievable prosthesis.

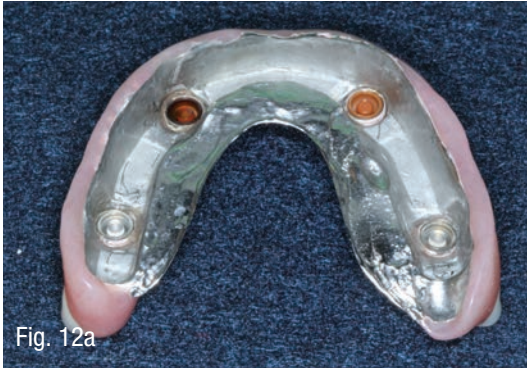
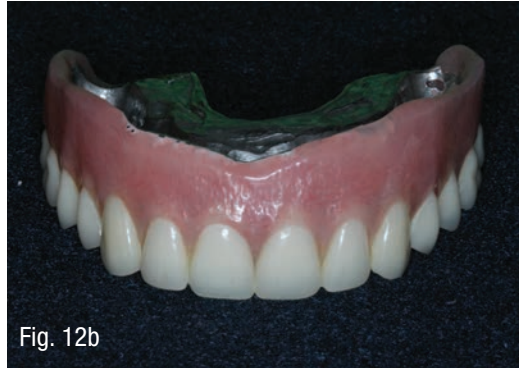
The patient was completely edentulous; the maxilla and mandible were restored with implant-supported overdentures retained on milled titanium bars (Figure 12). The patient had never been satisfied with the retention of the maxillary prosthesis since fabrication (2015), reporting relatively easy dislodgment in vertical direction. He desired a more retentive maxillary prosthesis.

Figs 12a-b: Initial clinical presentation of the maxillary implant-supported bar-retained overdenture, exhibiting suboptimal retention.

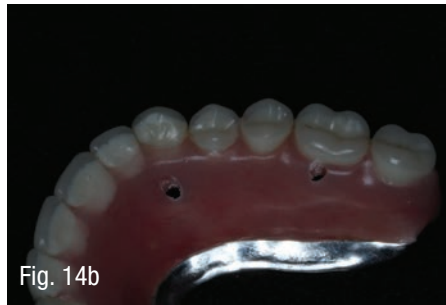
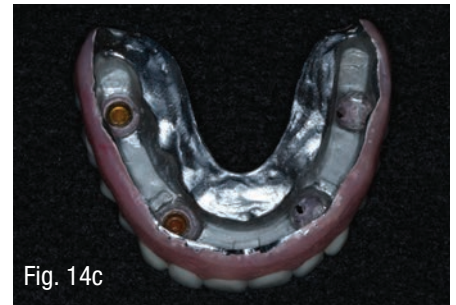
Figs 14a-c: Removal of the attachment matrices (a) and provision of vent holes on the prosthesis (b). It is evident the removed matrices are damaged and not reusable (c).

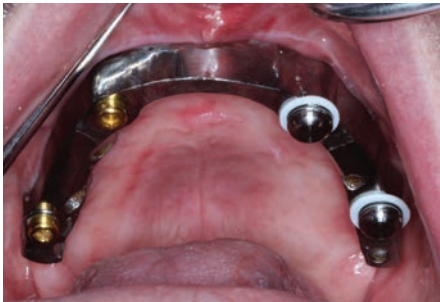
Fig 15: White block-out spacer rings placed on the attachment matrices.

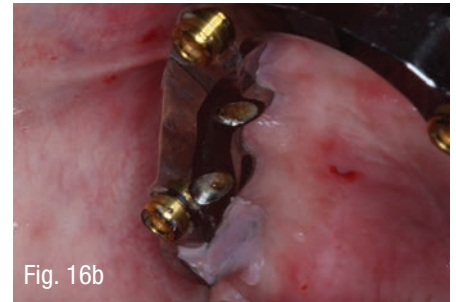
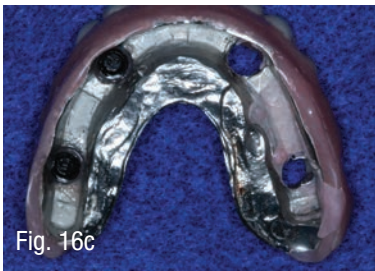
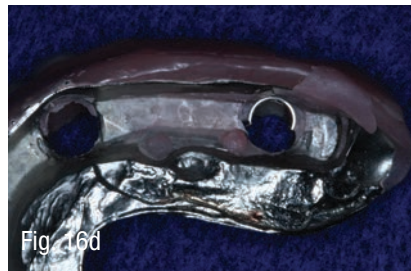
Figs 16a-f: Remainder of the pink auto-polymerizing acrylic retained on the bar after retrieval of the overdenture (a, b), the intaglio and polished surfaces of overdenture (c, d, e) and the retrieved matrix (f).

All 4 locator abutments on the maxillary bar were replaced with fresh abutments. This resulted in improvement in retention; however, the issue with non-simultaneous and inadequate engagement of the abutments by the matrix elements still persisted. The matrix elements were picked up intraorally separately on the right and left sides. The matrices were removed by drilling around them from the intaglio surface of the prosthesis and a small vent hole was created without damage to the prosthetic teeth. The retrieved attachment matrices were damaged and not suitable for further use (Figure 14). White block-out spacer rings were placed on the attachment matrices (Figure 15) and auto-polymerizing pink PMMA acrylic resin was used to pick-up the left side attachments first. This was done uneventfully and resulted in optimally positioned and secured matrices in the intaglio surface of the prosthesis. When the same procedure was performed for pick-up of the right side matrices, the prosthesis got locked in and simple retrieval was not successful. Digital dislodging forces and the “back-action hammer” were not sufficient for retrieval; hence, a diamond bur in a high-speed hand-piece was used to cut a trough around the estimated location of abutments lingual to the prosthetic teeth with no damage to the prosthetic teeth. Due to inability to remove the prostheses after preparation of a conservative trough, the hole was extended and the matrix element was completely removed. This resulted in damage to the underlying locator abutment and the matrix. The prosthesis was then removed revealing the remainder of the pink auto-polymerizing acrylic resin on the bar and the intaglio surface of the prosthesis framework. This was suggestive of excessive amount of acrylic utilized and pushed around the parallel walls of the milled bar, which due to the intimate fit with the framework resulted in a non-retrievable prosthesis. It was also evident that the locator abutment matrix and matrix components were not reusable (Figure 16).

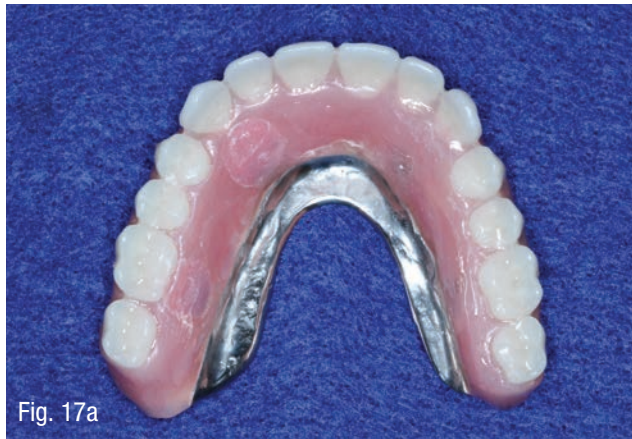
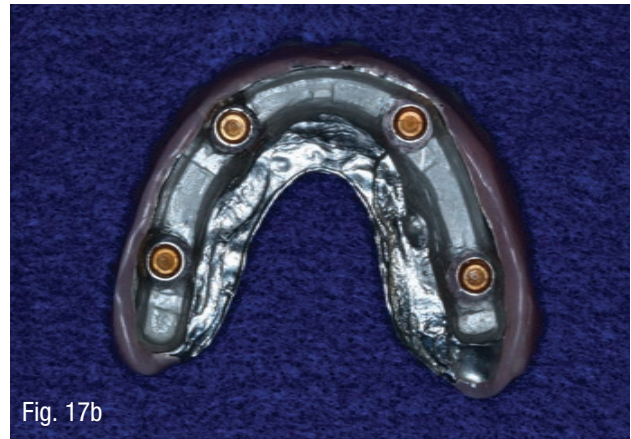
Figs 17a-b: The prosthesis with matrix elements incorporated was delivered to patient after polishing.

A fresh locator abutment was inserted and torqued in place and a fresh matrix component was inserted. Due to the intimate fit of the overdenture metal framework and the underlying bar, blocking out the bar structure yet ensuring adequate seating of the overdenture was challenging. A creative solution of applying a thin sheet of clear Cellophane on the bar was used to ensure adequate seating of the prosthesis, yet blocking out the parallel walls and underlying structures to prevent locking. Moreover a white block-out ring was placed on the locator abutment. The new matrix component was picked up with pink autopolymerizing PMMA acrylic resin by applying the material directly on the matrix through the large vent hole. After completion of polymerization, the prosthesis was removed and acrylic around the matrix was checked to ensure that the component was securely positioned. The prosthesis had improved retention due to optimal engagement of the matrix components simultaneously (Figure 17).
