# Management of a Dislodged Implant-Supported Crown Due to an Abutment Fracture: A Case Report

Fracture of implant components is a relatively common scenario encountered in prosthodontic clinical practice. This clinical report describes the management of a dislodged implant-supported crown due to a fractured prosthetic abutment in the esthetic zone. The fractured abutment segment was locked in the implant and was successfully removed without damaging the implant; hence, a new implant-supported crown could be fabricated. We also describe a similar case in which a locked-in abutment resulted in a modified treatment plan.

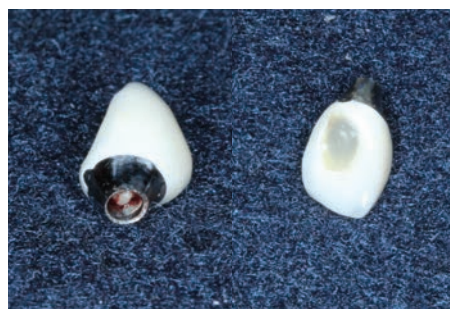
Figure 1: Separated implant supported prosthesis with intact composite resin and Teflon tape in the screw access channel with no screw. Note thin metal collar of prosthetic abutment.

Comprehensive extra and intraoral examination was performed. Findings of the extra oral examination were not remarkable. Assessment of the dislodged 22 crown revealed that the crown abutment had fractured and the fragment was present inside the internal connection of the implant along with the abutment screw. The metallic abutment of the separated prosthesis showed deformation (Figure 1).

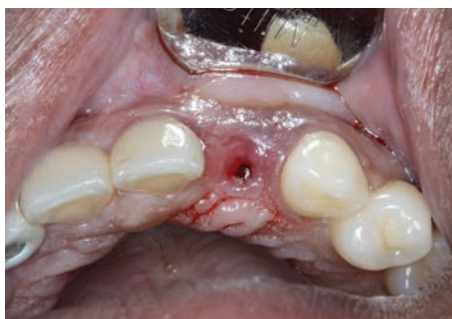
Figure 2: Clinical presentation after removal of the essix appliance revealed partial soft tissue coverage of the implant site with minor inflammation and bleeding associated with the use of the separated crown within the essix appliance for esthetic purposes.

soft tissues (Figure 2), and the patient reported inserting the crown into her essix appliance and utilizing the appliance as a provisional prosthesis for esthetic purposes (Figure 3). Hence, minor inflammation of the keratinized tissues around the implant site was visible possibly due to the contact with the fractured edge of the prosthetic abutment. No other abnormalities were detected in the site, and the patient reported no tenderness to palpation.

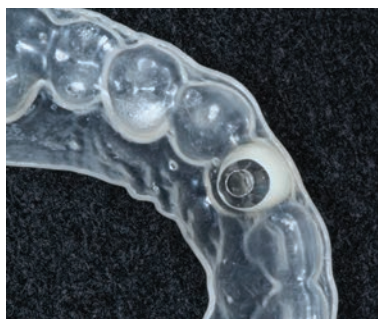
Figure 3: Essix appliance with separated implant-supported crown utilized by the patient for esthetic purposes as a provisional prosthesis.

the manufacturer (Figure 6) and reschedule the patient. Insertion of a healing abutment was not possible due to the presence of the fractured segment. The patient was informed and provisionalized with the same essix retainer and the crown inside the retainer. The patient was advised to be careful since the separated crown could be a choking hazard.

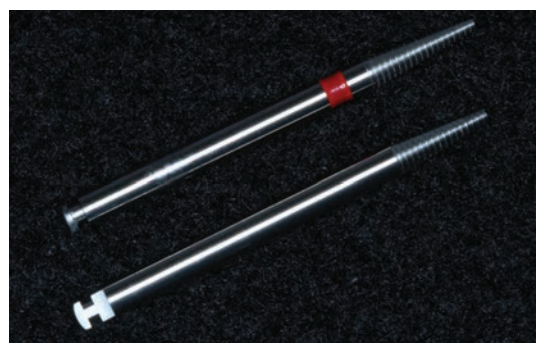
Figure 6: Abutment retrieval instrument (Fragment Fork) provided by the manufacturer (AstraTech) to aid with the retrieval of the fractured abutment fragment.

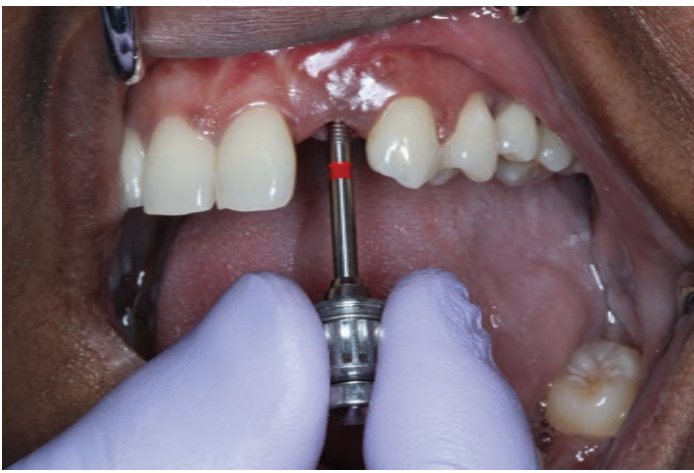
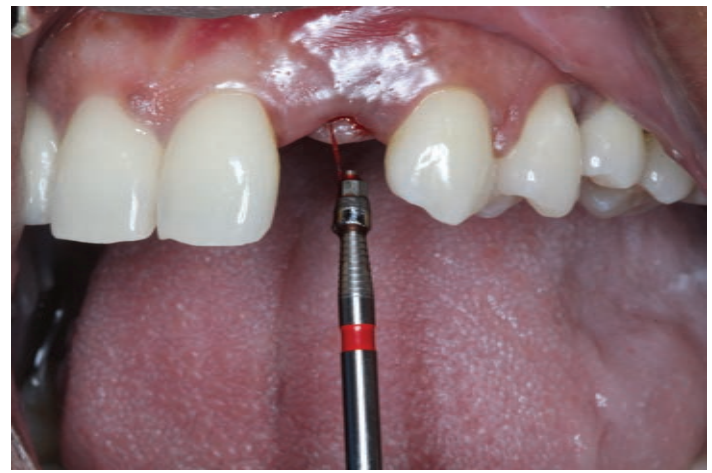
Figure 7: Removal of the fractured abutment fragment with the retrieval instrument.

At the next appointment, the retrieval tool was utilized according to the manufacturer's recommendation. The Fragment Fork was inserted into the restorative driver handle, inserted inside the implant and the fractured abutment fragment, and engaged the segment. Once the segment was firmly engaged by the retrieval tool, slight

wiggling motion loosened the stuck segment and allowed its removal (Figure 7). After retrieval of the abutment fragment, it was separated from the retrieving instrument with a haemostat (Figure 8), and the fragment and the implant were carefully inspected. No damage was present to the internal aspect of the implant. No debris or fractured pieces were detected. A 3x4 mm healing

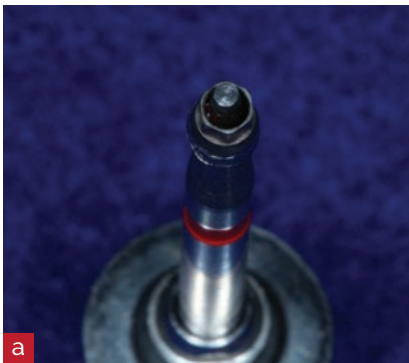
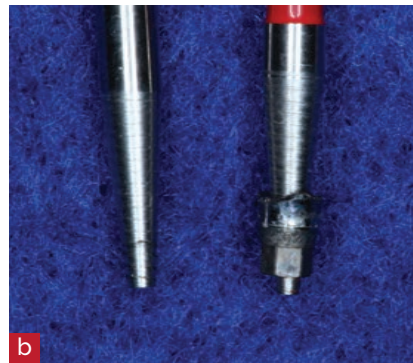
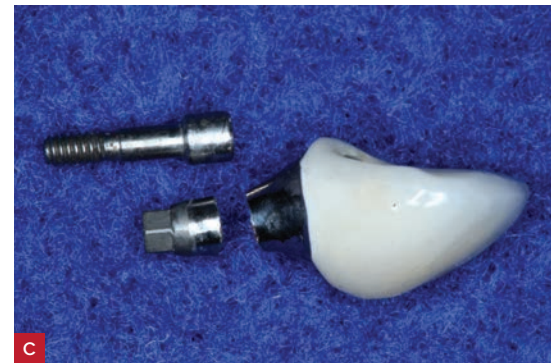
Figure 8: The retrieved fractured abutment fragment is shown on the retrieving instrument (a, b) and after separation from the retrieving instrument (c).

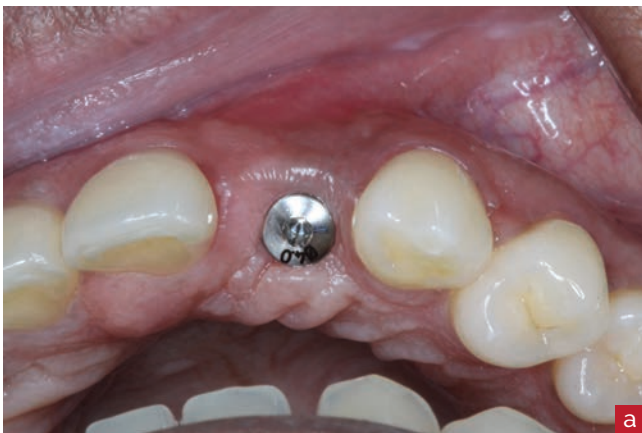
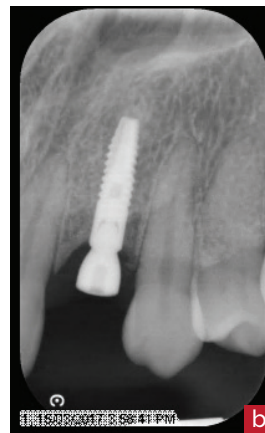
Figure 9: a. 3x4 mm healing abutment inserted, b. periapical radiograph showing complete seating of healing abutment after removal of the fractured abutment fragment.

abutment was inserted and hand tightened, and a periapical radiograph was obtained to confirm complete seating and integrity of the implant axial walls (Figure 9). The patient was ultimately provisionalised with an implant-supported acrylic screw-retained crown before proceeding to the definitive crown. The patient was very satisfied with the outcome of treatment.

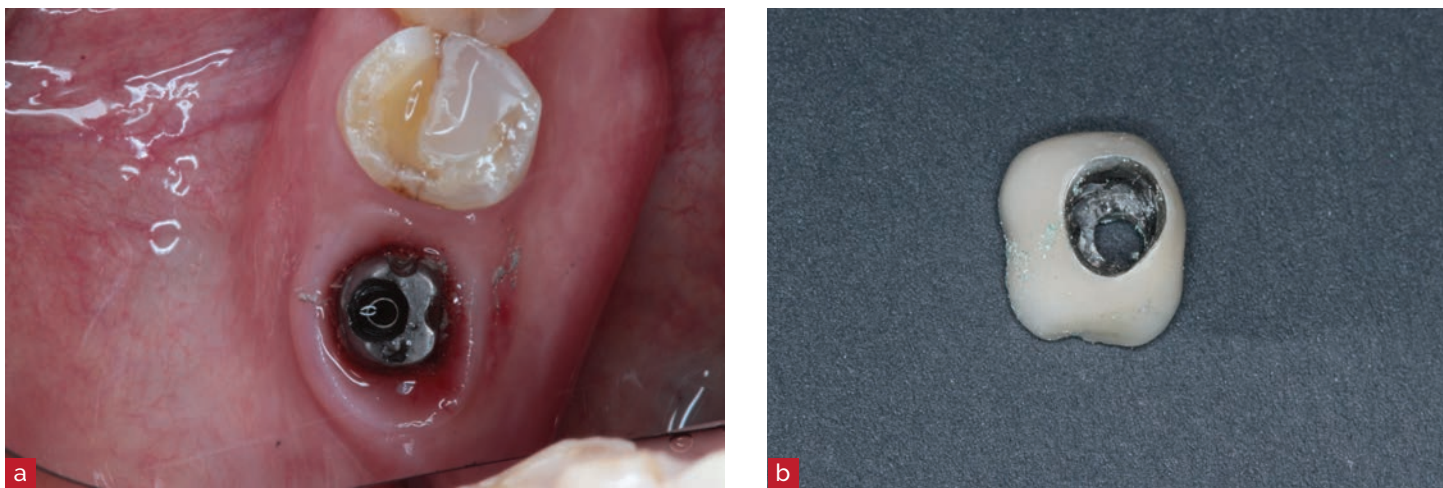
Figure 10: Clinical presentation of the wedged in abutment in 46 implant (a) and the retrieved crown.

The fractured wedged in segment was retrieved uneventfully in this case, and a new implant-supported crown will be fabricated. However, this is not possible in all situations with a wedged in abutment segment. For example, in a similar case (Figure 10), attempts were made to retrieve a screw-retained PFM implant-supported crown in the 46 site to address an open contact and the resultant patient complaint of significant food impaction. Despite unimpeded access to and complete

removal of the intact abutment screw, retrieval of the abutment was not successful. It appeared that – similarly to the current case – the prosthetic abutment was wedged and locked in the internal aspect of the implant. As a result, to address the patient's chief concern, the abutment screw was reinserted, torqued, and a pick-up impression with the existing crown was obtained for a new crown to be fabricated. The new crown was later cemented onto the existing wedged abutment. This second case represents a scenario in which the treatment plan was modified from a screw-retained to a cement-retained prosthesis due to the fact that the prosthetic abutment was not retrievable (Figure 10).
